Dolby Laboratories Inc

Field Bulletin No. 161

INTERMITTENT AUDIO ON CP55 WHEN POWER IS SWITCHED ON

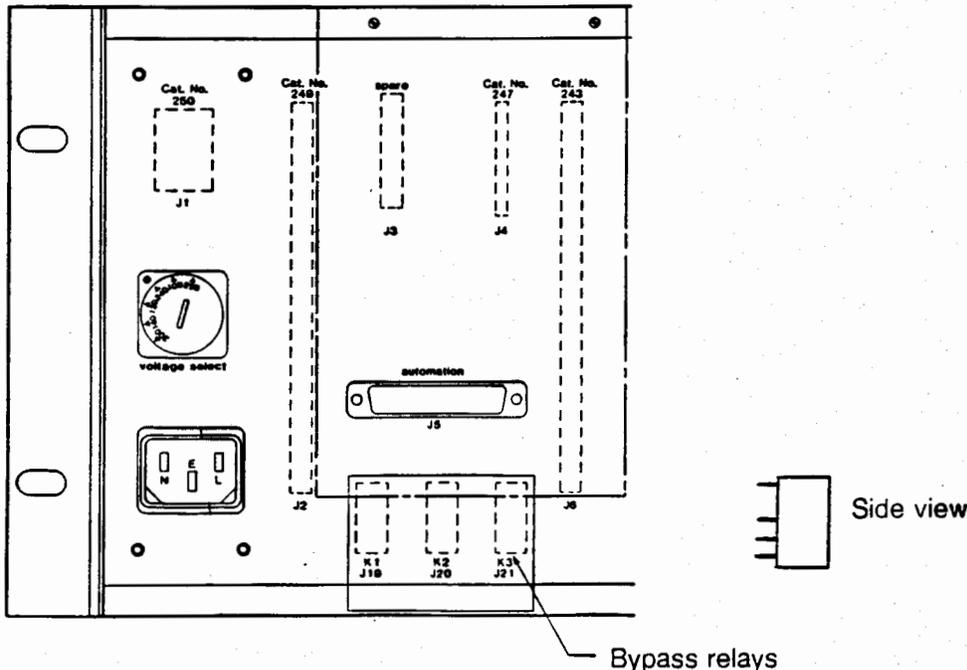
Symptom No audio or a long delay on one or more channels when power is applied or the unit is switched from bypass to normal (any format).

Cause Some relays manufactured by STC occasionally develop contact resistance when used to switch audio. STC relays are easily identified by their white color and the brand name marking.

Solution Bypass relays (K1, K2, K3) should be replaced with audio relay--Part No. 51015 available from Dolby Laboratories. Please provide the serial number of your cinema processor when ordering. The relays are mounted in sockets. Be certain to observe the same orientation when replacing them (dot should be at the top).
