Dolby Laboratories Inc

Field Bulletin 211

Model CP500

Cat. No. 675A Problems on Power Up

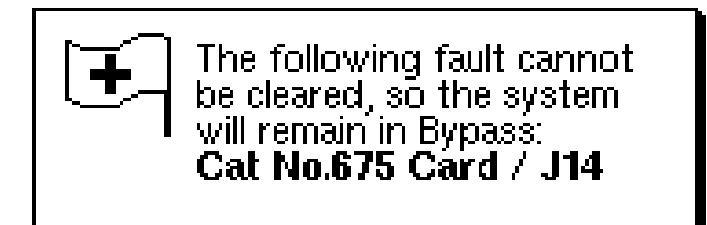
A small number of Cat. No. 675A boards within a known range of serial numbers have occasionally been seen to show a problem when the CP500 is switched on. The CP500 will display a message indicating a problem with either or both of the Cat. No. 675A cards in slots J12 and/or J14 (see example below). The unit will remain in bypass.

As an immediate solution, normal operation of the unit can often be restored by turning the unit off and on again using the power switch located inside the front panel. This may have to be done several times before the CP500 will boot up correctly. When the system has powered up correctly there will be no further occurrence of this problem while the unit remains powered.
